Lufttüchtigkeitsanweisung (LTA) Consigne de Navigabilité (CN) Direttive sulla Navigabilità (DN) Airworthiness Directive (AD)		FOCA AD HB-2020-006
Inkraftsetzung Mise en vigueur Entrata in vigore Effective Date	04 August 2020	Pilatus – P3 FOCA TC/TCDS No: None

Subject: **Fuselage – Fuselage to Horizontal Tail Fittings – Inspection, Replacement**

Applicability: Model P3-03 and P3-05 aeroplanes, all Serial Numbers (S/N).

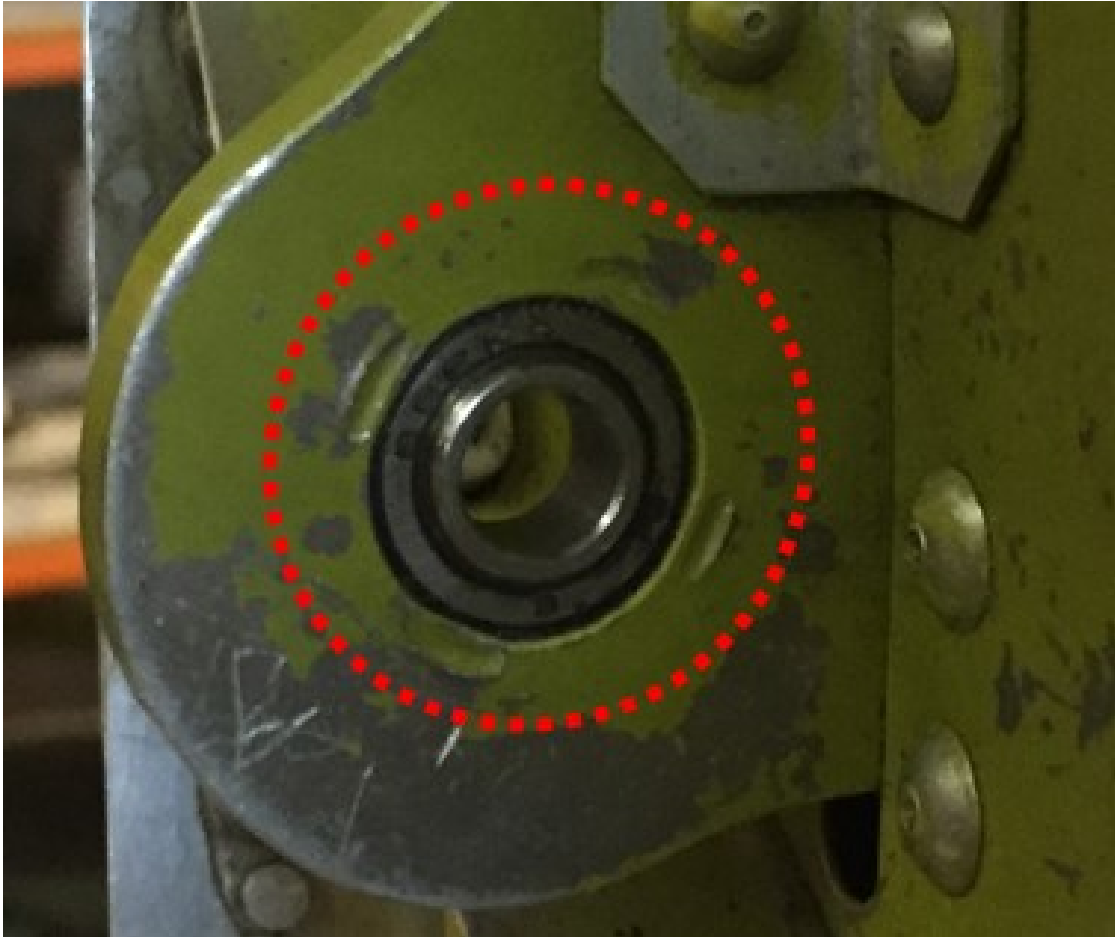
Fuselage to horizontal tail fitting: original manufactured by Pilatus Flugzeugwerke AG
