Lufttüchtigkeitsanweisung (LTA) Consigne de Navigabilité (CN) Direttive sulla Navigabilità (DN) Airworthiness Directive (AD)		FOCA AD HB-2020-006
Inkraftsetzung Mise en vigueur Entrata in vigore Effective Date	04 August 2020	Pilatus – P3 FOCA TC/TCDS No: None

Subject: **Fuselage – Fuselage to Horizontal Tail Fittings – Inspection, Replacement**

Applicability: Model P3-03 and P3-05 aeroplanes, all Serial Numbers (S/N).

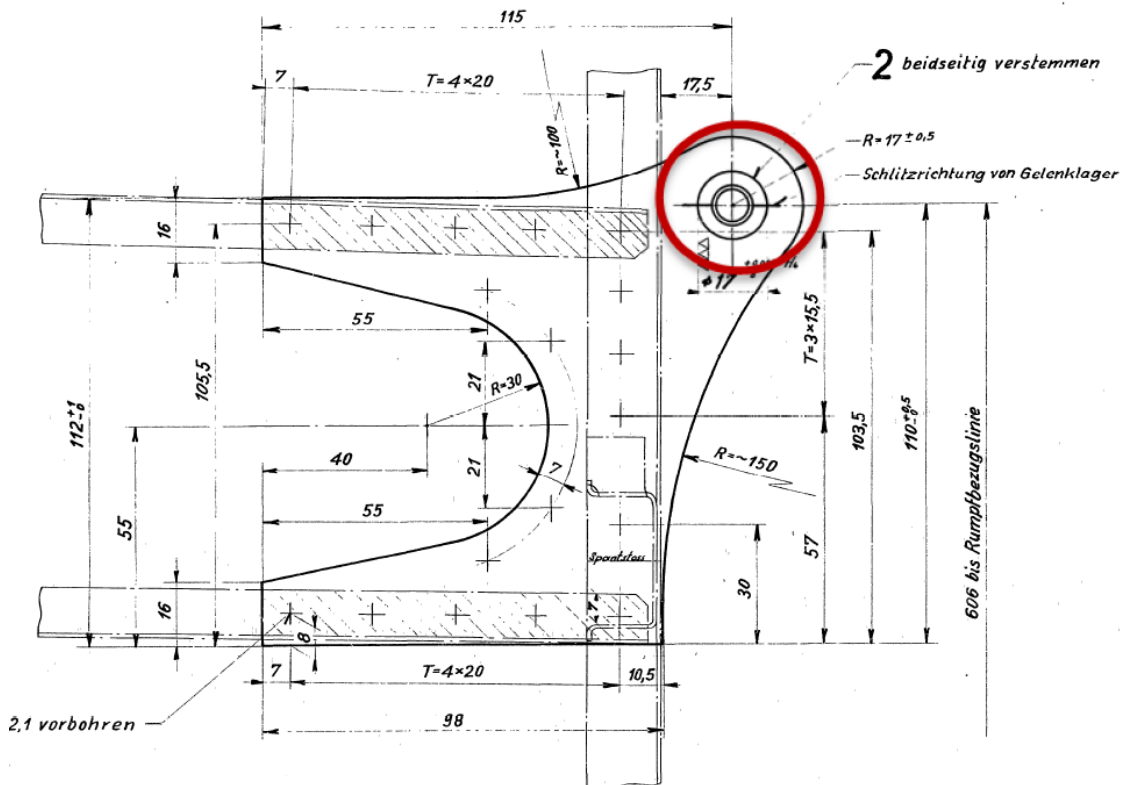
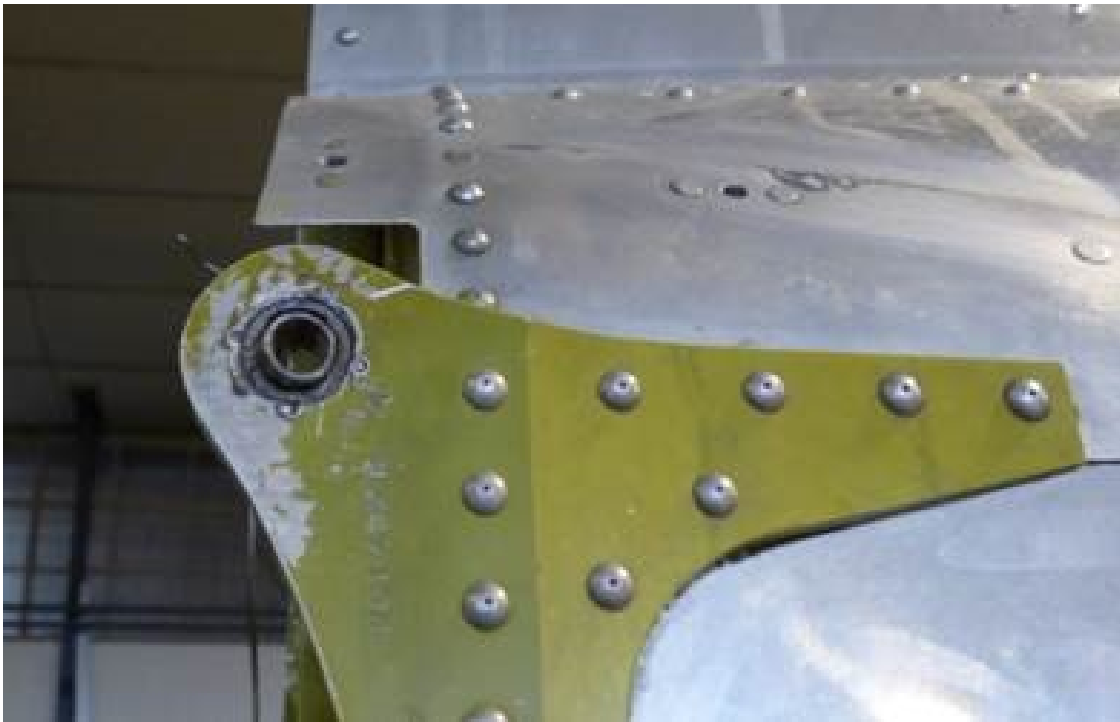
Fuselage to horizontal tail fitting

Fuselage to horizontal tail fitting: damage caused by using a centre punch tool during maintenance

- (3) If during the inspection required by paragraph (1) of this AD any fuselage to horizontal tail fittings with signs of damage caused by using a centre punch tool are found, before next flight, replace the fitting with a serviceable part or repair the fitting in accordance with an approved repair solution.
